# Manhole Inspection Summary

Manhole # S51AA\_003MH

Insp Date: **2/27/08 10:06 AM**

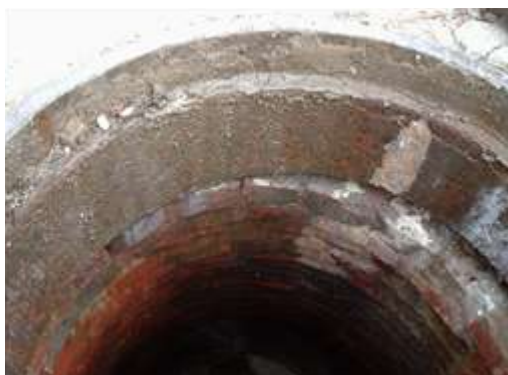
Defect 1

**Chimney / Frame Adjustment** ☒ Exists Material: **Brick** ☐ Parged Height: **6** (in.)

Condition: ☐ Sound ☐ Cracked ☐ Root Intrusion ☒ **Loose Brick** ☐ Deteriorated

Infiltration: ☐ None ☐ Joint ☐ Cracks ☐ Mortar ☐ Roots ☒ **Wall**

adjustment joint

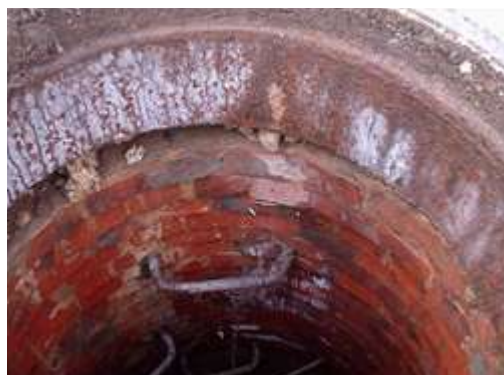
Defect 2

**Frame** Offset: **1** (in.) Condition: ☐ Sound ☐ Cracked ☒ **Leaks**

frame leaks

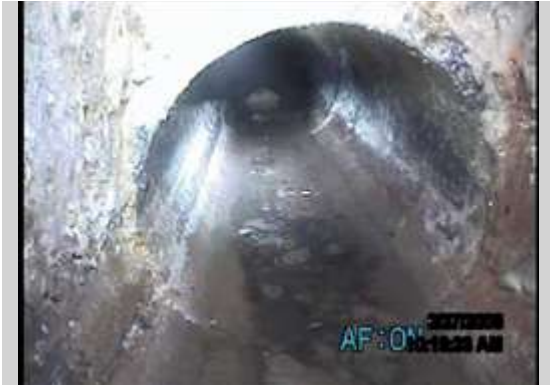
12 O'Clock Outflow

Pipe Height: **8.4** (in.) Rod and Bar (Angled)  
Pipe Material: **Clay** ☐ Pipe Lined  
Invert Depth: **10.85** (ft.) Flow Characteristics: **Fast**  
Deposits: ☐ None ☐ Mud ☐ Sludge ☒ Debris ☐ Grease  
Silt Depth: **1** (in.) Deposits Extent: **Light**  
Infiltration: **None** Pipe Seal Cond: **Sound**

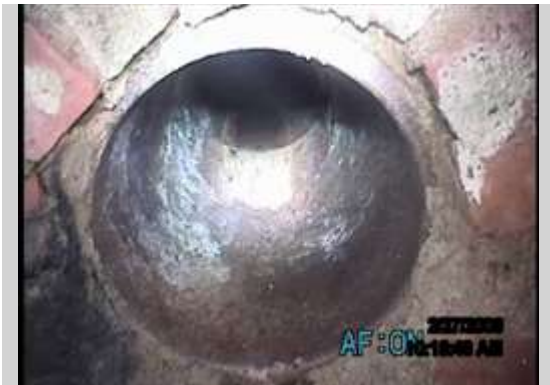
3 O'Clock Inflow

Drop In @ 3 O'Clock

Pipe Height: **8.4** (in.) Rod and Bar (Angled)  
Pipe Material: **Clay** ☐ Pipe Lined  
Invert Depth: **8.95** (ft.) Flow Characteristics: **Fast**  
Deposits: ☐ None ☐ Mud ☐ Sludge ☒ Debris ☐ Grease  
Silt Depth: **1** (in.) Deposits Extent: **Light**  
Infiltration: **None** Pipe Seal Cond: **Sound**

Drop: **Inside** Rod and Bar  
Angled: **Yes** Reading: **9.45** (ft.)  
Inv Depth: **10.45** (ft.)

Drop Condition: **Open**

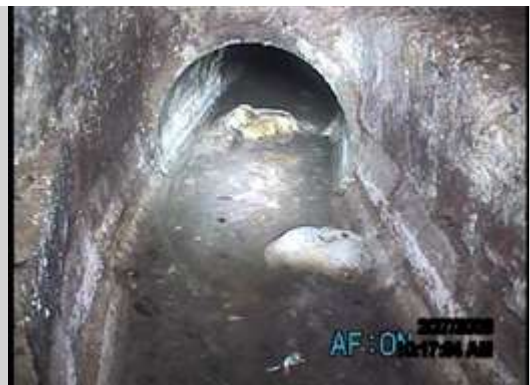
9 O'Clock Inflow

Deposits: ☐ None ☒ **Mud** ☒ **Sludge** ☐ Debris ☐ Grease

Silt Depth: **4** (in.) Deposits Extent: **Medium**
